2.5 HEALTH AND SAFETY AT WORK (asbestos) REGULATIONS 2016

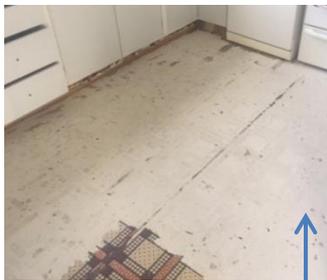
Photo 1 the area and tools used could be now contaminated with asbestos fibres. This situation requires the immediate advice and services of an accredited asbestos-specialist.

Photo 1 Vinyl wear layer separated from its backing

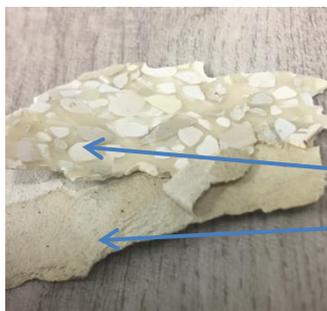
Photo 2 is a close-up view of an asbestos-backed vinyl.

Vinyl wear layer

Cardboard type backing with asbestos fibres as part of the make-up.
